Issue 545

June 2025

A Snapshot of ALTITUDE DEVIATIONS

～ 高度逸脱の事例から ～

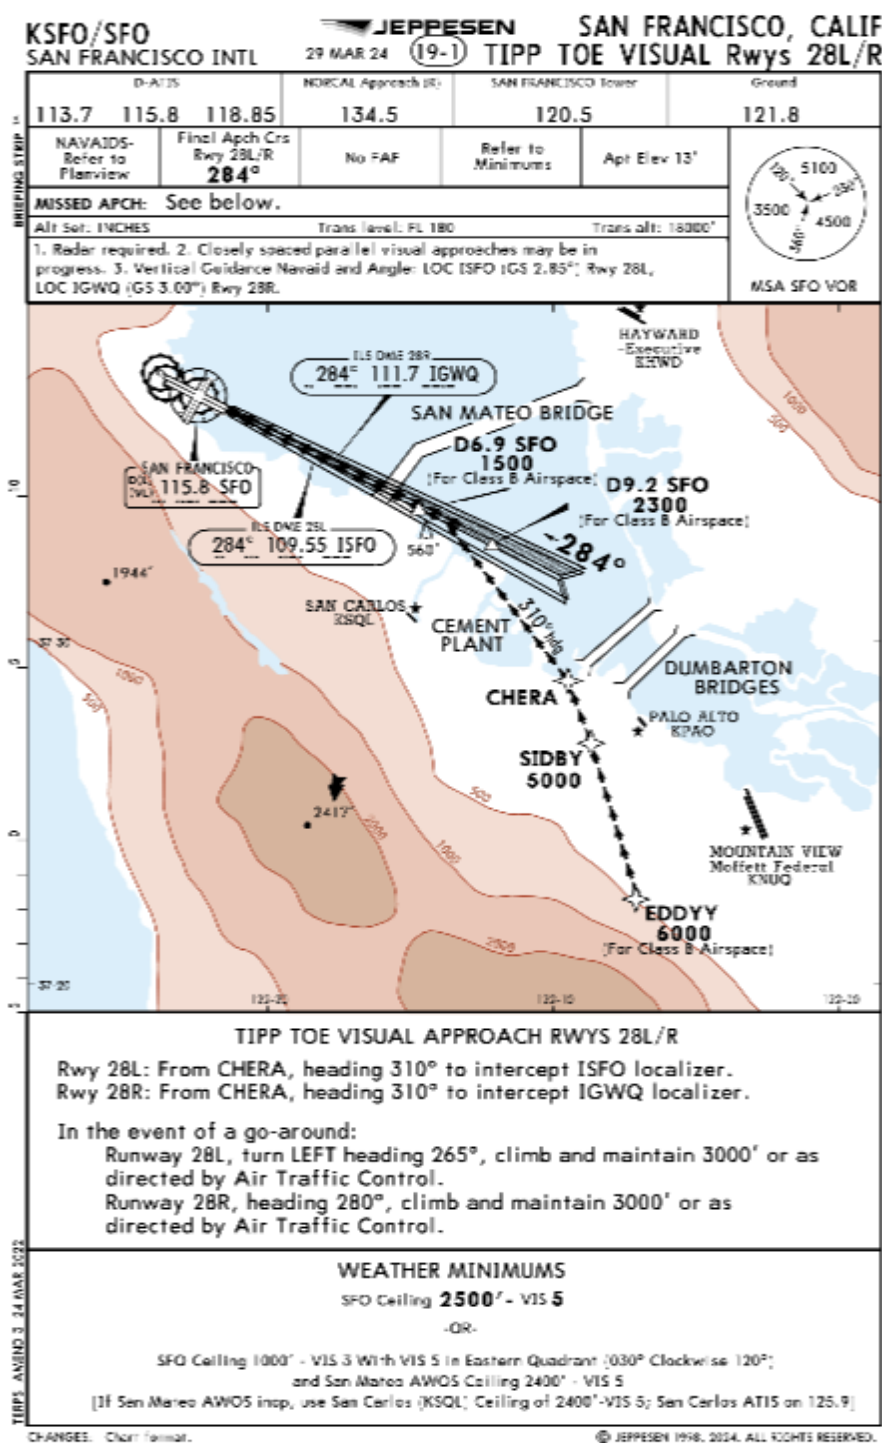
PF が Flight Level Change mode を選んで降下角の監視を怠って降下したのが不適切と思われる。

VNAV または Vertical Speed mode を使用して 3° の Path 角をなだらかに降下していれば Work Load も下がって余裕が増し、Risk management が好ましく行えたと思われる。

(訳者注により右図を追加)
