## ～ 冬の運航から ～

# CALLBACK

Issue 551

## WINTER FLIGHT OPERATIONS

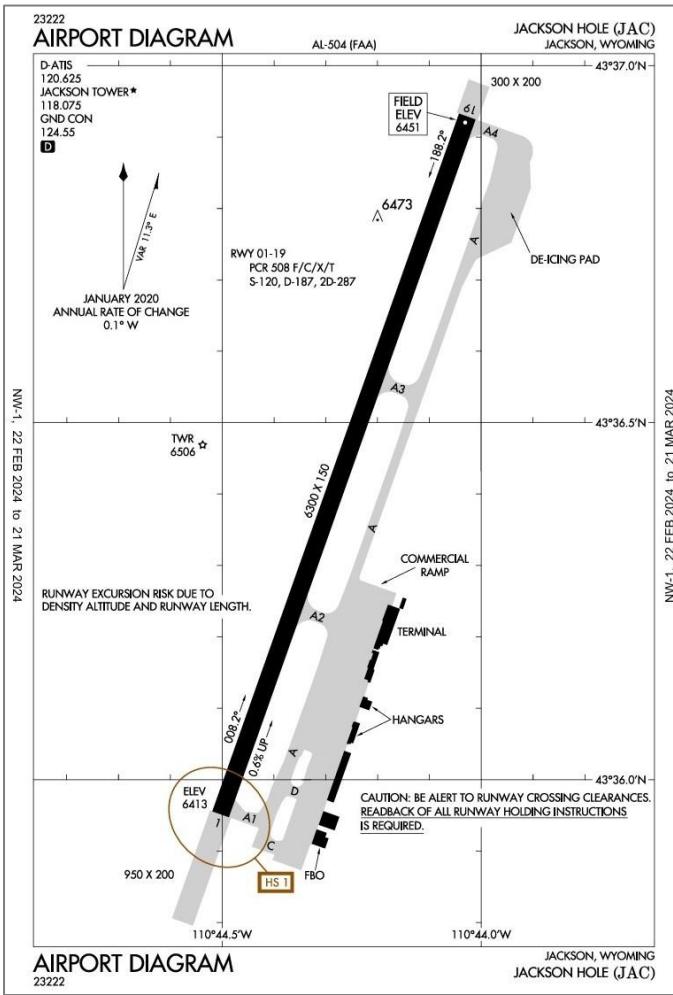
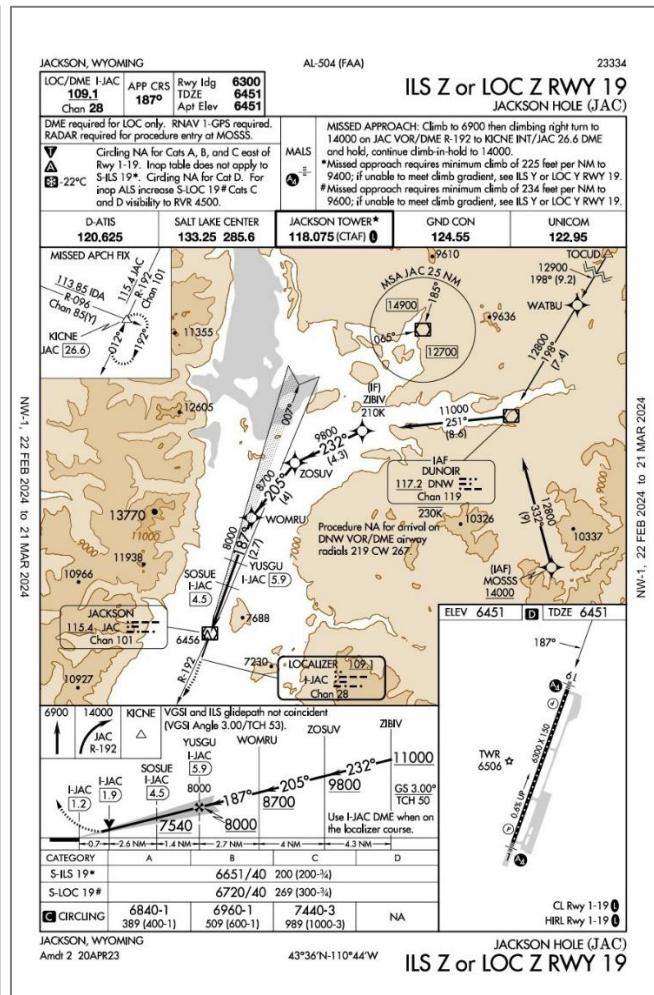
Jackson Hole Airport (JAC) の AIRPORT DIAGRAM 及び ILS Z Chart を参考添付

■ 私は、機長の JAC(Jackson Hole Airport \* 1 )への便の、査察飛行をしていました。天候はこの時期の JAC では標準的なものでした（夜間、-SN、BR、3/4 視程 500Ft OVC、ガスト、-12 度）。機長は飛行中、ディスパッチからフィールド・コンディション（以下 FICON）とブレーキング・アクション（以下 BA）に関する最新情報を定期的に入手していました。私たちの 15 分前に着陸した同じ会社の機体からは、ロールアウト中の BA はグッドだったという報告もありました。滑走路 19 の FICON は 20%の圧雪で、BA はグッド（ドライスノーが 1/8 インチ以下）との報告でした。滑走路は除雪され、少し前に除雪ブラシをかけられました。フラップ 40、自動ブレーキ最大、ILS Z、滑走路 19。着陸重量 115k。機長は 10-7 着陸データテーブルを使用して、ブレーキナンバーをグッド～ミディアムに設定し、安全な方法で着陸しました。アプローチは良好で、計画通り 1000Ft の直前に接地しました（雪で滑走路のマーキングが見えないため判別は難しいですが、PAPI の真横に接地しました）。BA は良好でした。機長は自動ブレーキとスラストリバーサーをフルに作動させ、GS が 80Kts になるまで維持しました。誘導路 A2 を通過し、A1 出口に進むことを選択しました。GS は 40Kts でした。残り約 2000FT あつたため、速度を 40Kts に維持することを選択しました。A1 への接近（約 1000Ft 手前）において、機長は減速を試みましたが（機体の速度は約 30Kts）、減速時に方向制御に問題が生じ始めました（横滑り）。標準操作手順（SOP）に従い、機長はブレーキを解除し、前輪ステアリング、ラダー、差動ブレーキを使用してセンターラインに戻りました（横風は約 5Kts）。A1 付近の、滑走路端での BA は大幅に低下していました。そのため当然ながら着陸時の滑走路距離は長くなり、A1 への進入時に 13Kts までしか減速できなかったのでした。機長は 13Kts で旋回するのは安全ではないと判断し、直進して減速を継続したため、オーバーラン（100Ft ? \* 2）に入りました。機長は 3Kts まで減速を続け、そこで U ターンして A1 に無事到達しました（タワーの許可を得て）。機長の報告には、得られた適切な教訓がまとめられていました。副操縦士（FO）も、対地速度をモニターし、（状況を考慮して）対地速度が速すぎたと思った場合はそれを指摘しました。

\* 2 訳者注記： FAA Airport Diagram によれば、JAC のオーバーランは 950Ft × 200Ft
