Issue 554

## What Would You Have Done?

### ～ あなたならどうしますか ～

#### Part 91 – だまされた、燃料は給油されていなかった … ファルコン 900(リアエンジン 3 発機)の機長の報告

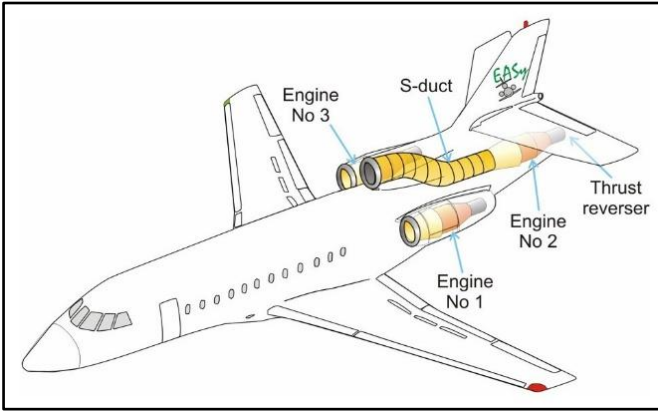
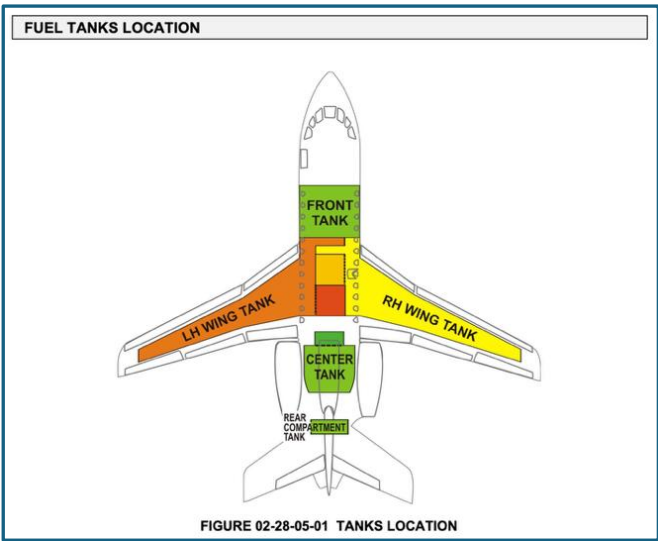
**FIGURE 02-28-35-00 FUEL HOSE**

Single Point Refuel Panel \* に給油量を Full ではなく Partial 給油が設定されている場合、No.3 タンクに燃料は供給されません。…残念ながら、この(燃料計ではなく給油に関する)問題は、フライトクルーに伝えられていませんでした。乗務員は、シミュレーターでの訓練時と同様に、機内での燃料計の不具合時でも、すべてのタンクの合計残量と消費量で、正確に反映されるものと考えていました…つまり、No.3 タンクの燃料計が機能していないので、No.3 タンクに燃料が残っているかどうかの確認方法がまったくない状態でした。

Falcon 900(3 発機)の燃料系統の仔細は不明ですが、当事者たちの勝手な想定で燃料搭載と供給手順に失敗し、No.3 タンクがほぼ 0 だったようで、上昇中 8,000ft で燃料が枯渇し右側の No.3 エンジンが停止してしまったものです。MEL (Minimum Equipment List) による修理持ち越しを受け入れる場合は、当日の飛行の実施にどのような影響があるか、整備サイドと運航サイドで入念な安全確認の議論と検討が必要です。

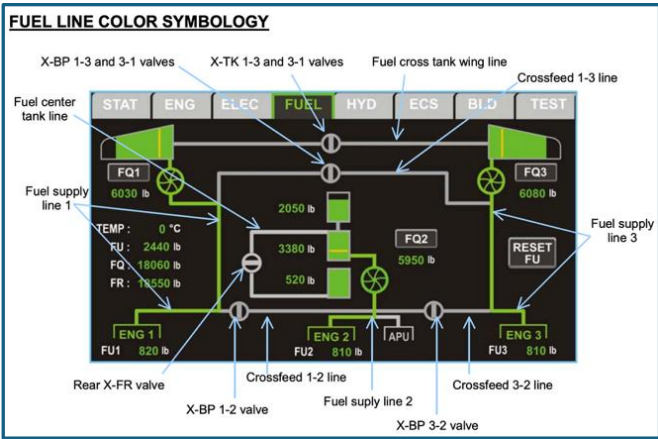
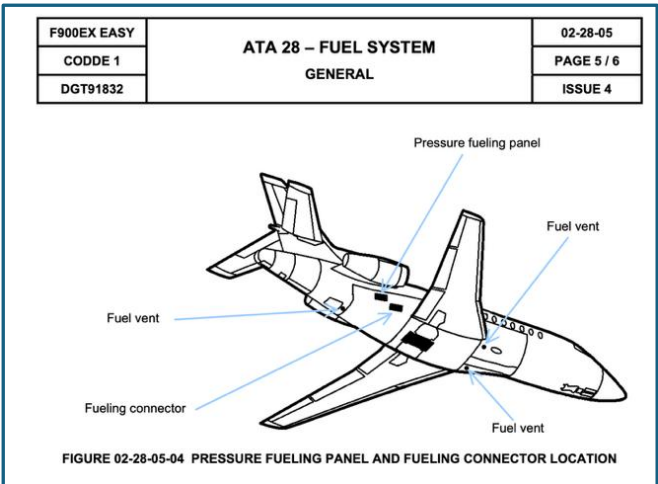
**FIGURE 02-28-35-01 PRESSURE FUELING PANEL**

The refueling pressure must be between 30 psi and 50 psi maximum. For a partial refueling, refueling stops automatically when the selected fuel quantity is attained (accuracy is of 50 lb).
