# CALLBACK

From NASA's Aviation Safety Reporting System

Issue 557

## ～ 予期せぬ事態への備え ～

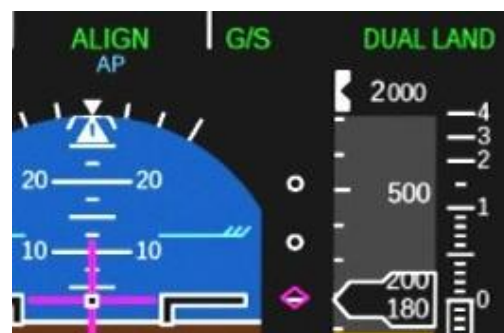
\*FMA の DUAL LAND の表示 (右上)  
参考 (記者補足)

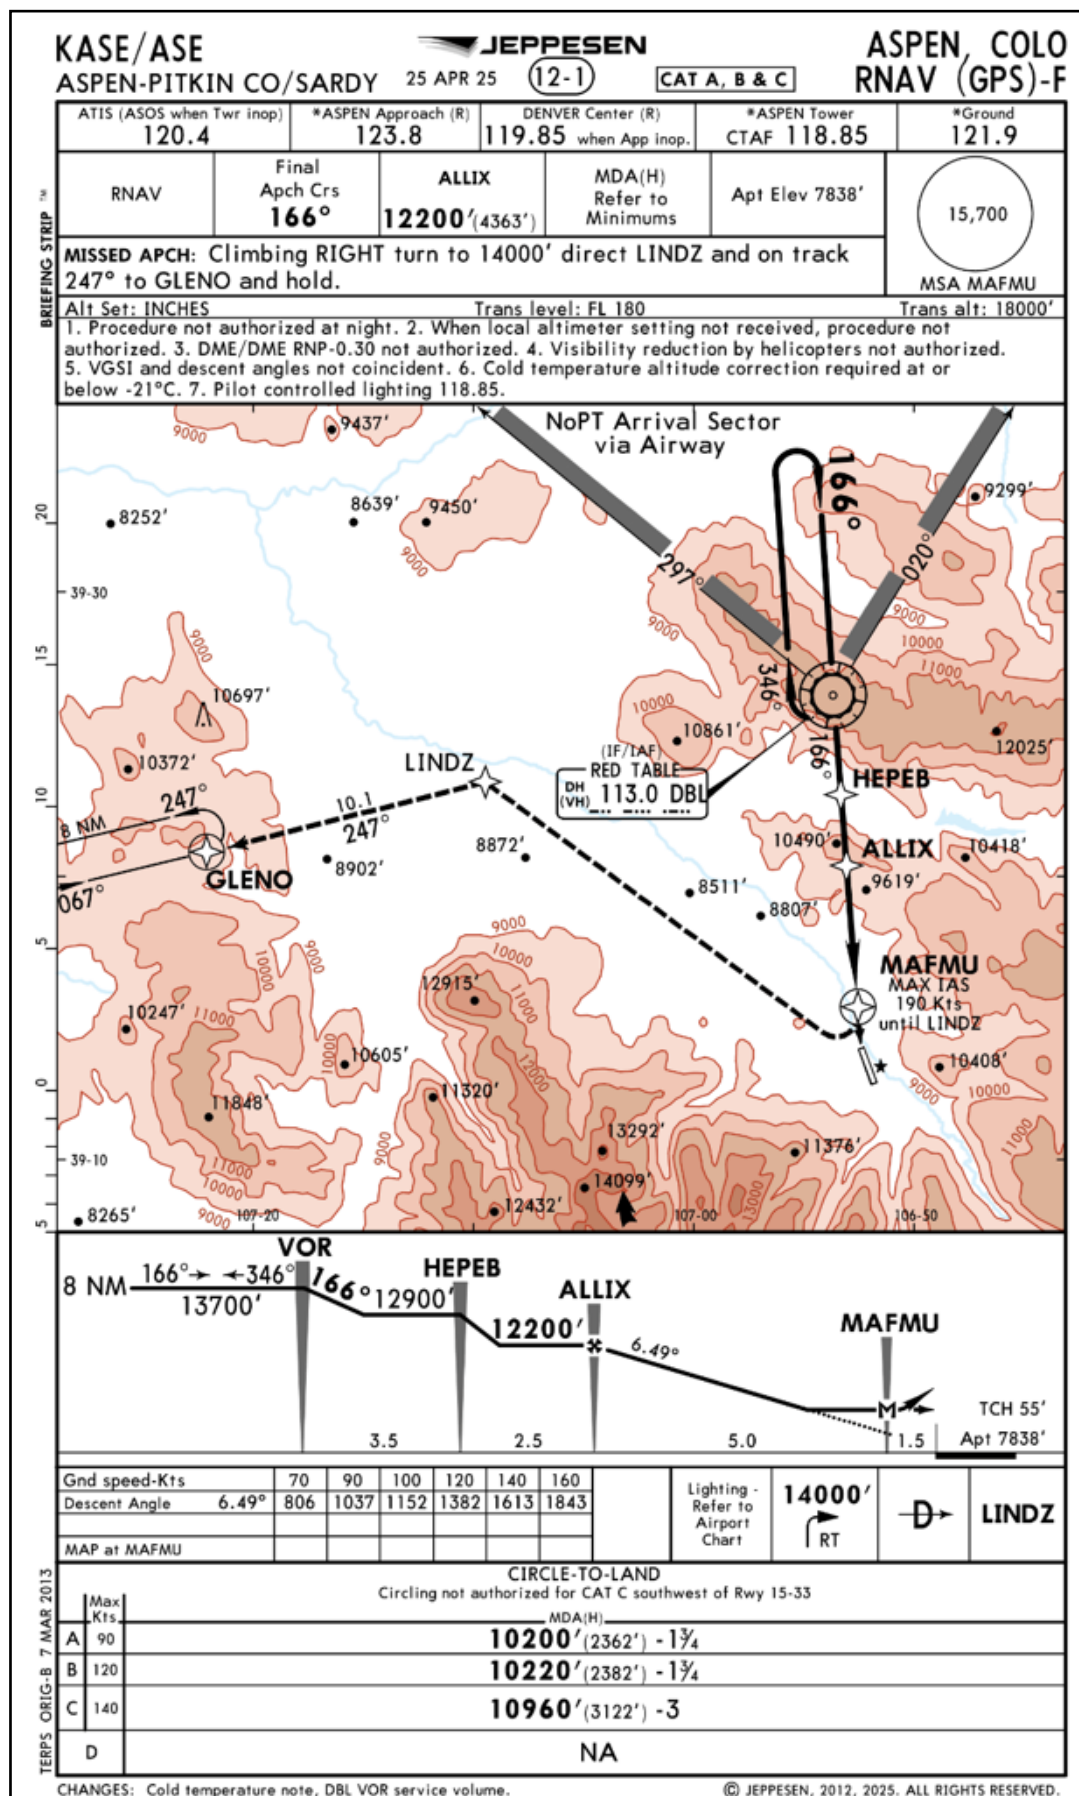
参考（訳者補足）：アスペンはコロラド州の有名なリゾート地。

現在は RNAV-E Approach は改訂されて、-E Approach が current となっているようです。  
 機体サイズの制限から CAT-D の機体は就航できず、CAT-C の E175 が多く就航しています。
