# CALLBACK

Issue 559

August 2026

## ～ 米国の複雑な空域におけるジェネラル・アビエーション機の飛行 ～

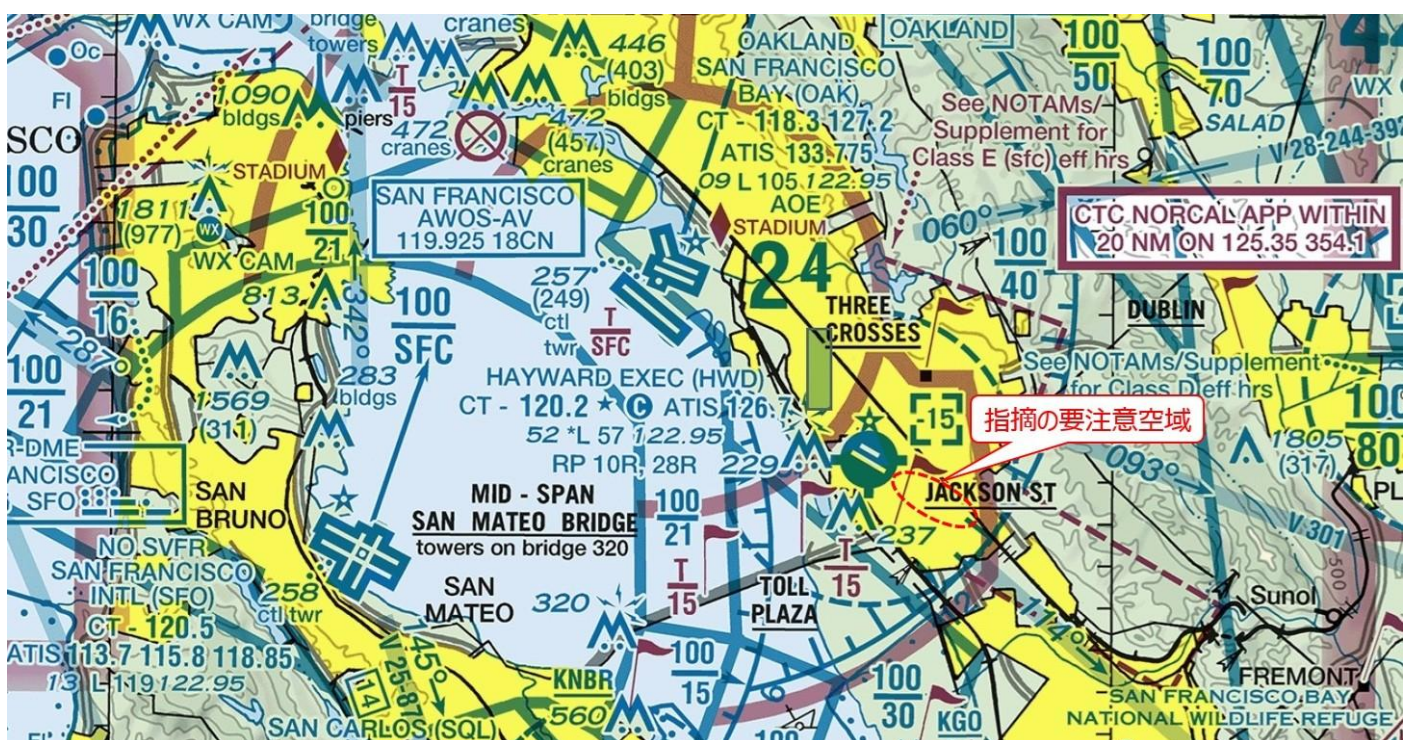
訳者補足 : Hayward Executive Airport (HWD) 周辺の、Sectional Chart

HWD 空港の滑走路 28L への RNAV (GPS) アプローチを IFR で飛行中のビジネスジェット機が、前方 3Nm、1,000Ft 下方に、TCAS で表示される他機が存在を認め、雲から出たところで、自分より低い高度を飛行中の VFR 機を視認しました。衝突の恐れはありませんでしたが、RA の回避指示に従いました。

混雑したこのエリアの低高度は VFR 機を通過させるコリドーになっていて、IFR でのアプローチ中に雲を抜けて視界が開けた場合は、直ちに VFR 機を探すことが最優先事項になるとのことです。

■ HWD 空港滑走路 28L への RNAV (GPS) アプローチを実施中、ファイナル・アプローチ・コースおよび **LPV \* 3** パス上で IMC の状況にありましたが、前方約 3Nm、1,000 フィート下方に TCAS で表示される他機を視認しました。IMC での飛行中で、ATC から他機の情報を知らされましたが、同機とは交信していないとのことでした。高度約 3900 フィート (MSL) で雲を抜け、約 2Nm 先の、自機より低い位置で、こちらと接近する針路をとっている VFR 機 Y を視認しました。そこで、11 時の方向に、こちらへ接近してくる他機および空港を視認した旨を ATC に通報しました。ATC から滑走路 28L へのビジュアル・アプローチのクリアランスが出ました。その約 2 秒後に TA を受信し、続いて約 3 秒後に TCAS RA が発出されました。当該機を視認しており、衝突の恐れはありませんでしたが、それでも RA (回避指示) に従いました。VFR 機は、我々の機首の約 300 フィート下を通過していきました。VFR 機との接近を回避した後、私たちはそのままビジュアル・アプローチを継続しました。これはこの場所で行く問題でした。VFR 機は、クラス B、C、および D 空域や現地の地形を回避するためにこのコリドーを利用しますが、その際、雲からの離隔が最小限となることも少なくありません。また、空域の構成上、VFR 機はこの地点へ流入してくることになるのですが、それらの機体が ATC と無線交信を行っていることは稀です。HWD への IMC 下でのアプローチ中、ATC がアプローチ・クリアランスを取り消し、再度アプローチを行うためのベクター指示で旋回させることも珍しくありません。アプローチ中に雲を抜けて視界が開けた時点で(場合は)、直ちに VFR 機を探すことが最優先事項となります。特に週末の日中に RA がしばしば作動することがあります。
