Issue 531

April 2024

航空安全情報自発報告制度は、わが国では(公財)航空輸送技術研究センターが VOICES を運営していますが、航空大国の米国では NASA が ASRS を運営し、毎月 CALLBACK を発行しています。この E-Journal は JAPA の運航技術委員会が CALLBACK の邦訳を紹介するものです。

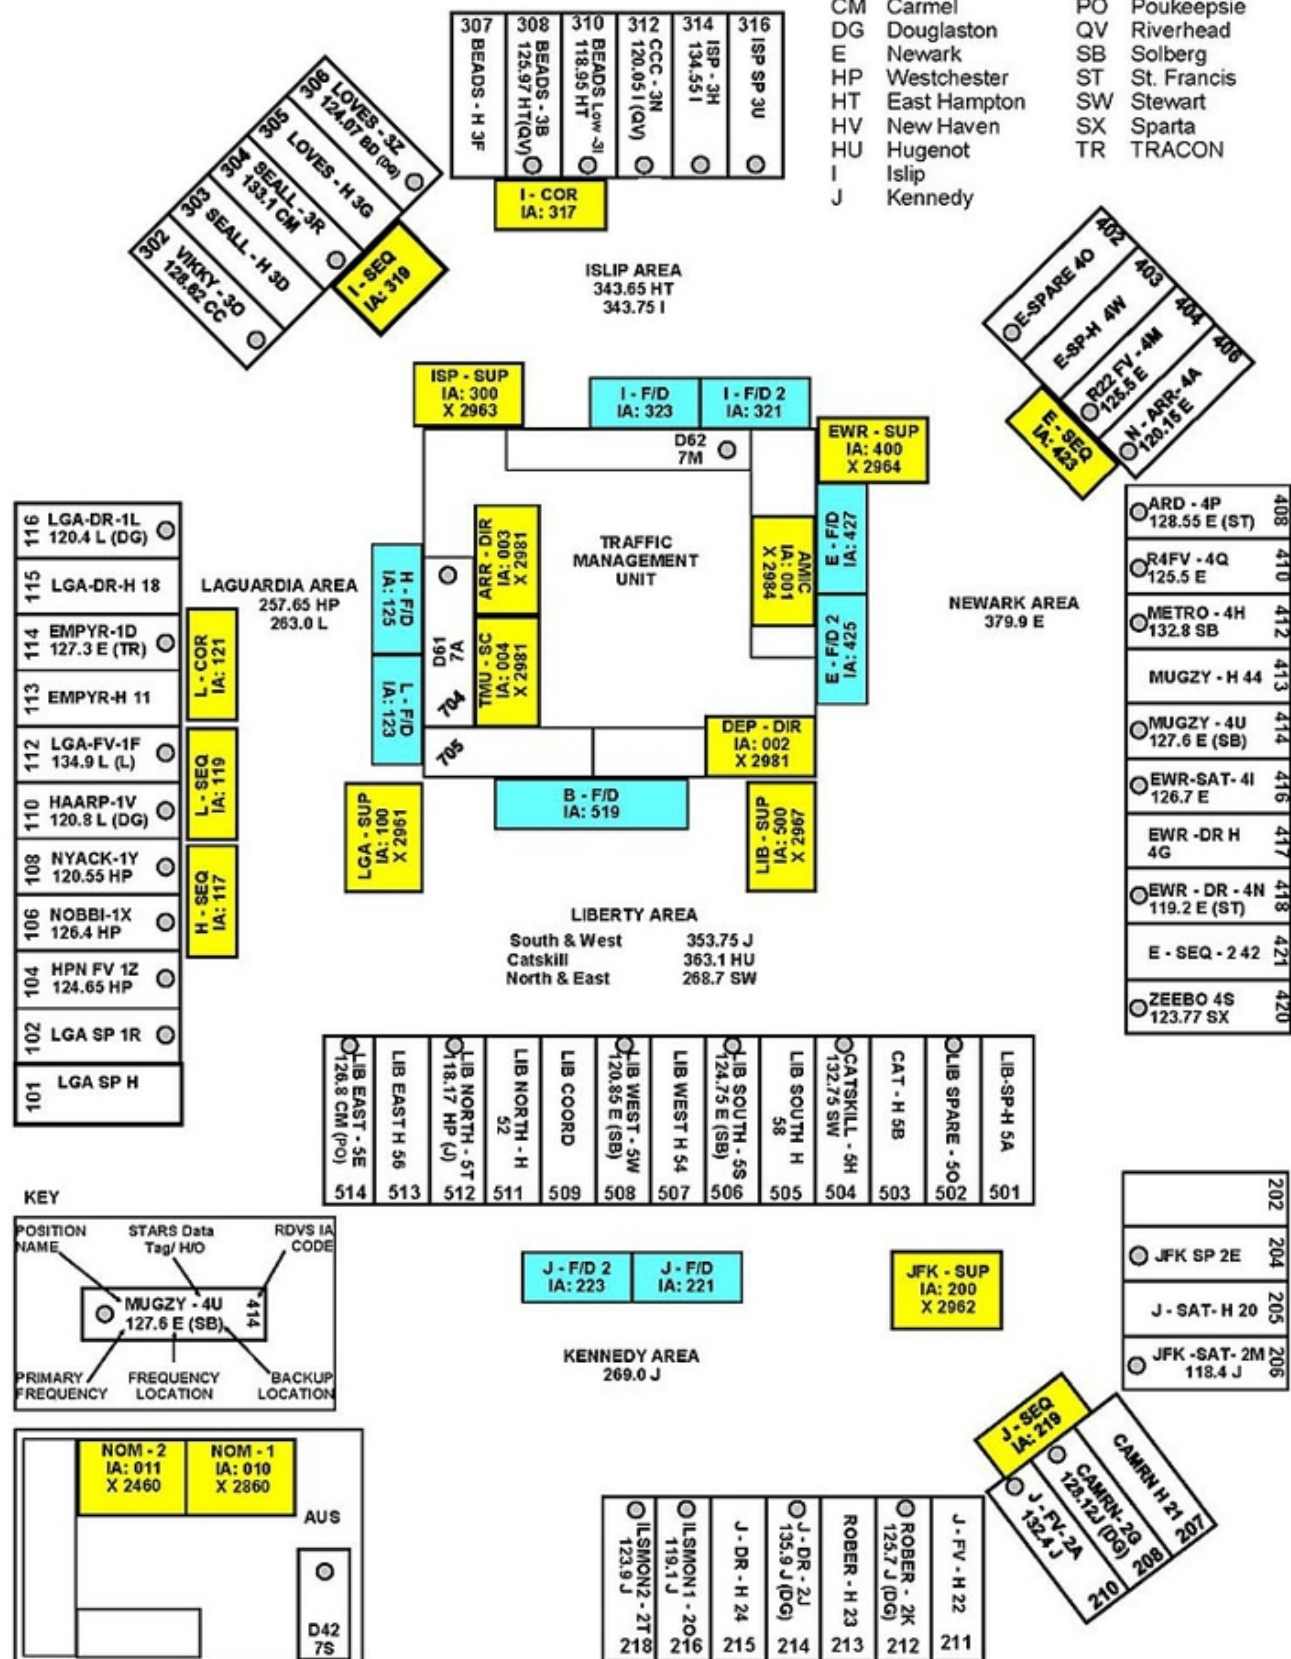
訳者補足: NewYork RAPCON 席配置図

BACK-UP FREQUENCY LOCATIONS

CC	Calverton	L	LaGuardia
CM	Carmel	PO	Poukeepsie
DG	Douglaston	QV	Riverhead
E	Newark	SB	Solberg
HP	Westchester	ST	St. Francis
HT	East Hampton	SW	Stewart
HV	New Haven	SX	Sparta
HU	Hugenot	TR	TRACON
I	Islip		
J	Kennedy

■ 私は JFK(ケネディ空港)のレーダー管制施設で CAMRN/LENDY 地区 31s(Rwy 31IL/R からの離陸)席を担当していました。飛行場管制から滑走路 31L からの出発機があるとの連絡を受けました。その機は JFK5 出発経路で Breezy ポイントに上昇を行うと思っており、出発上昇経路では Canasie(CRI)VOR に直行し、その後 VOR から 223° のラジアルに進行するはずでした。しかし、出発機 X は CRI VOR から方位 223°に向けて飛行せず、Robbinsville (RBV)に向かっているように見えました。私が言う間もなく、出発管制官はそのパイロットに対してラガーディア空港 (LGR)の空域に深く侵入しないように修正させました。幸いにも、そのとき交錯するラガーディア空港への到着機はありませんでした。航空機 X は RBV に直行している様子でしたが、出発管制官はパイロットに何故方向を変えたのか問い質しませんでした。そのパイロットに Brasher 警告^(注)が発せられたとは思いません。このような問題は引き続き発生しています。これ以上どのように書けばよいのでしょうか。出発管制官は多忙すぎてパイロットの間違いをいちいち修正する暇がありません。ニアミスが発生する前に何とかしてほしいものです。

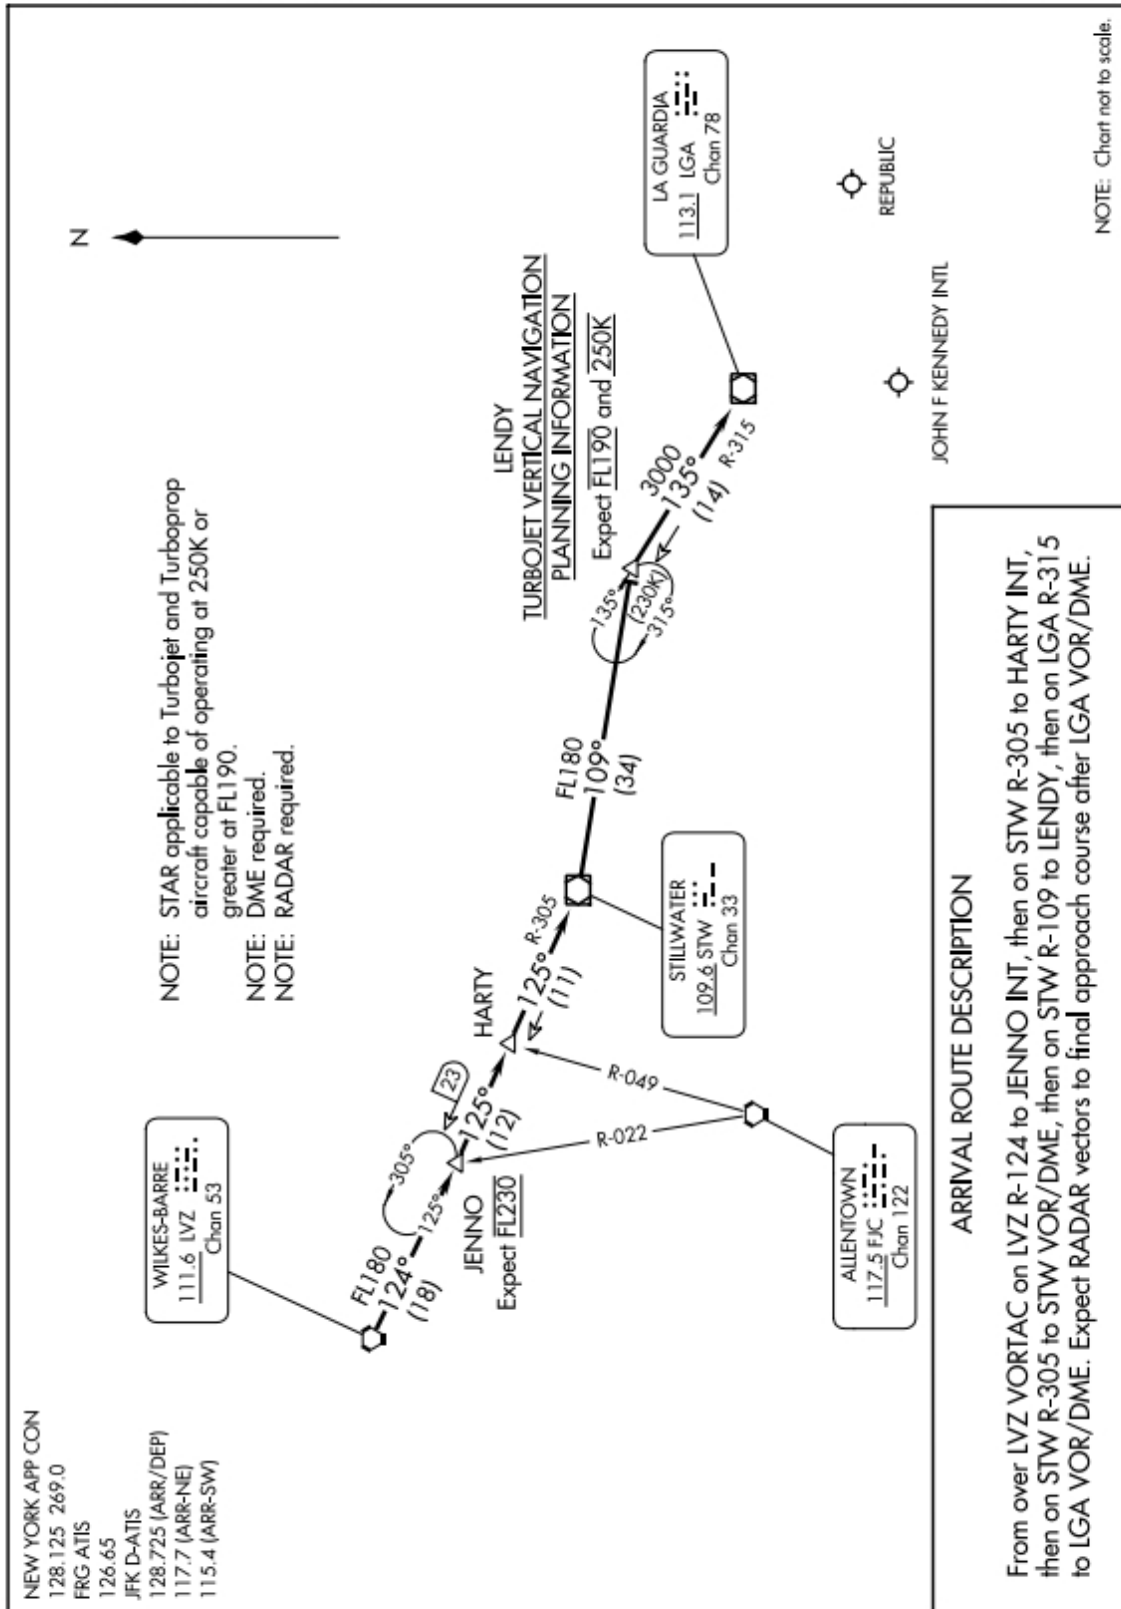
LENDY EIGHT ARRIVAL

NEW YORK, NEW YORK

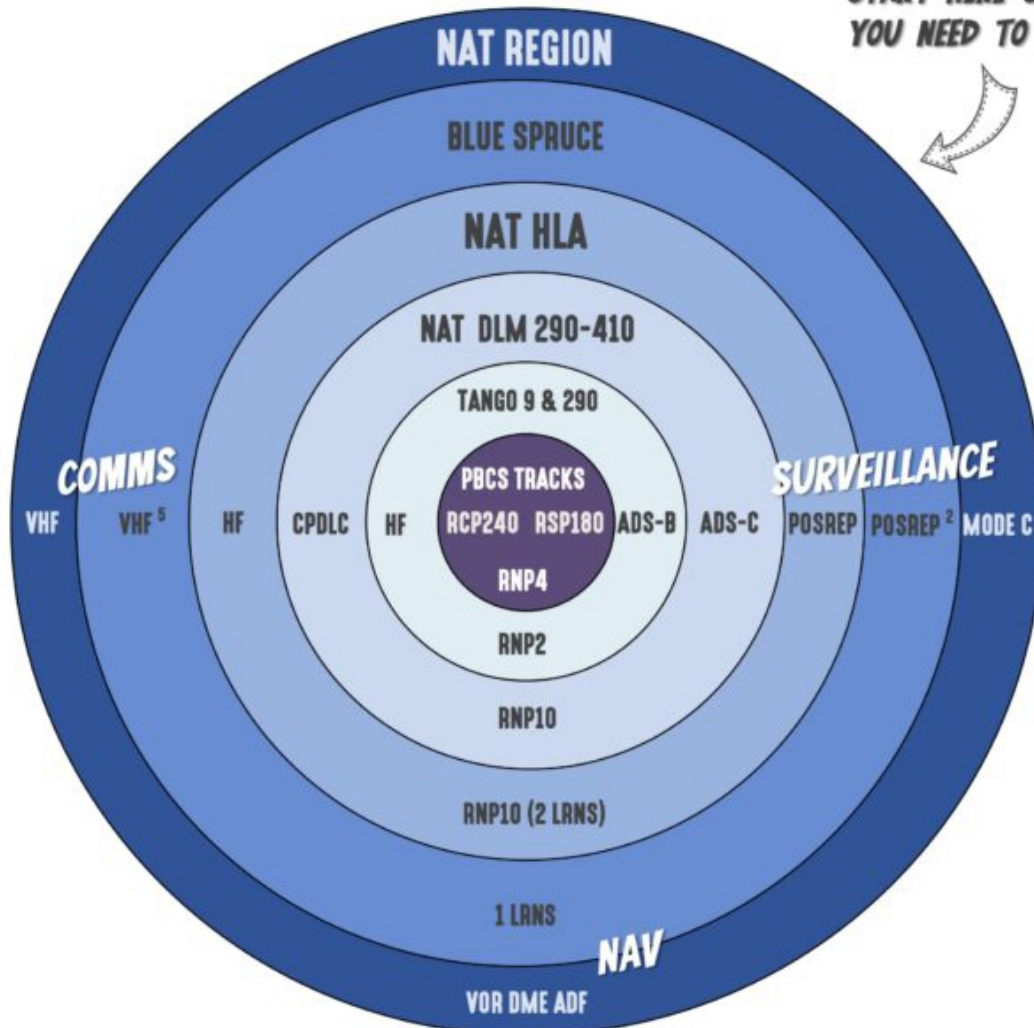
NORTH ATLANTIC AIRSPACE

START HERE & SEE WHAT YOU NEED TO GET IN

A FEW NOTES :

- 1 : The **NAT HLA** (formerly MNPS) is FL285-420 and everyone needs HLA approval in this area.
- 2 : **Blue Spruce** routes: 1 LRNS ok, VHF ok on most, but since 2021 more restrictive: datalink needed FL290-410 on southerly routes, ADS-B over Greenland (if no ADS-C), and HLA approval FL285-420.

■ 機長から SATCOM で連絡が入り、左側の GPS に問題があり、正常に機能していないとのことだった。航法は DME-DME モード(DME 2 局からの距離で位置情報を得る)が継続され、Actual Navigation Performance(実際の航行精度、ANP)の値は劣化し、現在 15 マイルにあるとのことだった。私は、彼らがいる空域は GPS ジャミングで知られていて(ブルガリア/ルーマニア/セルビア)^(注1)であると彼らに説明した。機長はそれを信じず、なぜかジャミングではなく、GPS ユニットが故障したのだと思ったのか...私が 1 週間前にも同じ空域で GPS ジャミングが起きていたことを伝えても聞き入れず、彼の見解を訴え続けた。私は整備部門にも連絡したが、彼らは GPS の異常は認められないとの返答であった。それを伝えても機長はまだ GPS ジャミングだとは納得せず、GPS ユニットの故障だと主張し続けた。そして彼は、ANP 値が 15 で GPS ユニットが 1 つ故障している状態で大西洋横断はできないと言い出した。私はサークル・オブ・エントリー・チャート(図 2: 北大西洋空域/NAT に入域する際の航法/通信要件を示す)を確認していたので、飛行を継続できると断言した。私はまた、現在は在来ルートを飛行しているのだから^(注2)、必要なのは VHF、VOR、DME、ADF、そしてモード C だけだと伝えた。彼は私の言うことを信じず、2 時間以上先の洋上飛行を開始する前に調査して返事をするよう指示してきた。彼は私が大西洋の横断を判断するのに足る十分な情報を提供できないことに苛立っているようで、納得できなければ目的地を変更すると言ってきた。...この時点で私の業務を引き継ぐ交代が来たので、私が状況を説明すると、彼は対処を調査すると言った。
