Issue 538

November 2024

航空安全情報自発報告制度は、わが国では(公財)航空輸送技術研究センターが VOICES を運営していますが、航空大国の米国では NASA が ASRS を運営し、毎月 CALLBACK を発行しています。この E-Journal は JAPA の運航技術委員会が注釈や補足説明を付加して CALLBACK の邦訳を紹介するものです。

### ～ランプ作業の危険性～

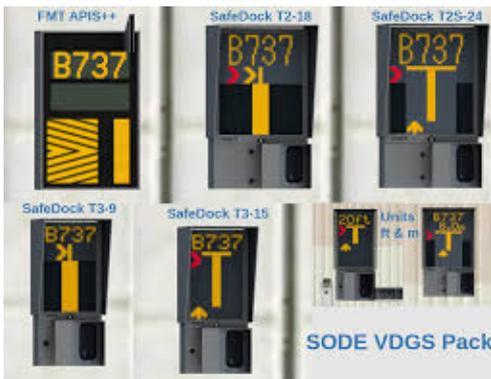
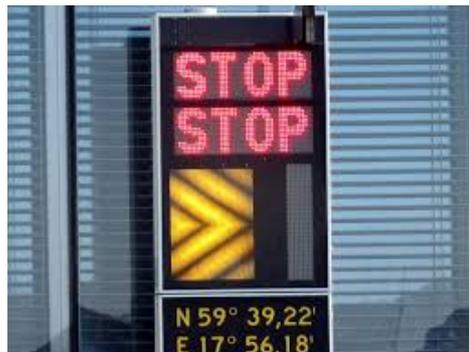
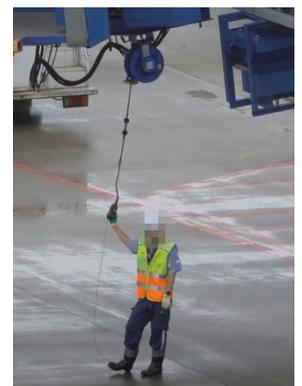
訳者補足(参考)：

訳者注：本件で使われている「セルフ・パーキング・システム」という言い方は日本国内では一般的ではなく、正式名称の Visual Docking Guidance System (VDGS) で呼称されることが多い。VDGS はさまざまなタイプの開発経緯があり、国によって、または空港によってさまざまなタイプの違いがある。最も新しいタイプの Advanced VDGS (A-VDGS) では、システムの異常/故障に備えて、マーシャラーが異常を見つけた時、緊急停止をパイロットに求める(有線の)リモコンのスイッチを手元に引き付けておき緊急停止のシグナルを表示させることが求められている。自動的ガイダンスでもマーシャラーは異常や故障がないか継続的に監視するよう教育/訓練がされているはずである。本件のマーシャラーの「チョックの準備の作業」やハンドシグナルによる緊急停止の合図は、かえって大きな事故につながる可能性もあり、望ましくないと思います。

■ ゲートに到着した当該機は、乗務員がセルフ・パーキング・システムを使用して進行している間に、リードラインを逸脱し、停止マークを通り越した。マーシャラーは...セルフ・パーキング・システムを使用して停止後にチョックを挿入するために停止マークの近くにいたが、航空機を停止させ、損傷を避けるために「緊急停止」のハンドシグナルを振らなければならなかった。

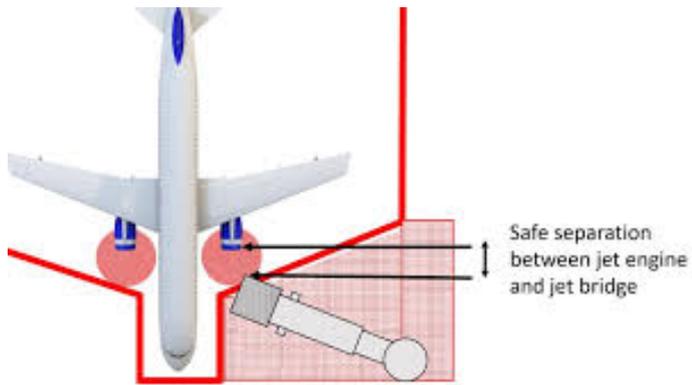
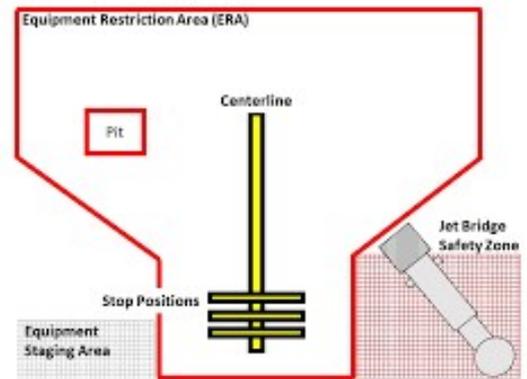
訳者補足(参考): 赤線の枠は、関係者、関係車両以外の進入が許されないランプ内の区画例です
